DAMAGE PROFILES IN SILICON AND THEIR IMPACT ON
DEVICE RELIABILITY

G. H. Schwuttke

International Business Machines Corporation

TECHNICAL REPORT No. 7, Part I
January 1976

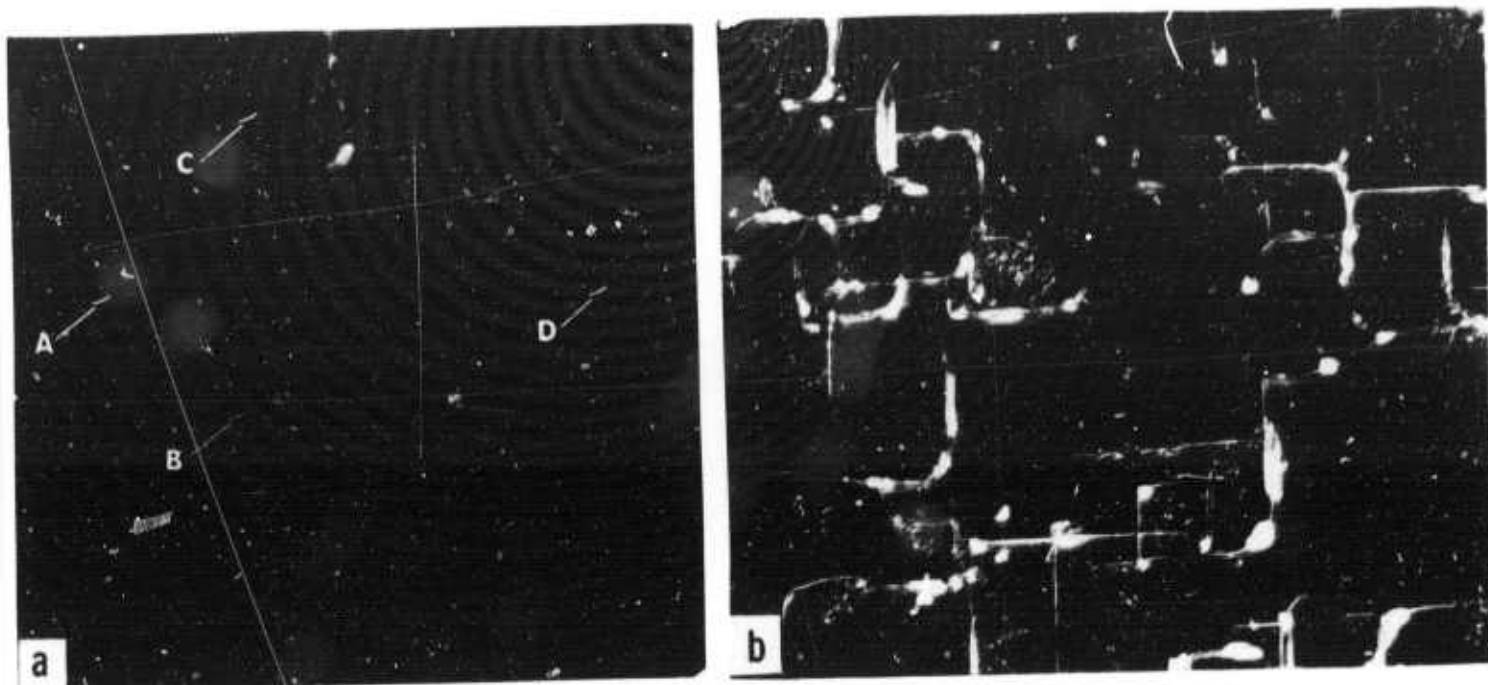
Fig. 1. Photomicrographs of damage in (001) silicon wafer surface after ISS showing abrasion and Hertzian cone fracture.

- a. Abrasion. ($\sim 370X$)
- b. Fracture. ($\sim 370X$)

ISS of silicon wafers produces two damage features: a fine, strongly directional abrasion leading to shallow grooves, and the formation of Hertzian fracture cones. Both features are displayed in the optical micrographs of Figs. 1a,b. The abrasion is more pronounced at low stressing power (Fig. 1a). The crack density increases dramatically with power input and is the leading feature at high power (Fig. 1b).

The grooves are bunched together in clusters and are indicated in the photomicrograph of Fig. 1a at positions marked A, B, C, D. A scanning electron micrograph of such a damage cluster shows clearly their groovelike nature. An example is given in Figs. 2. A typical cluster area in the examples shown in Figs. 1 and 2 is approximately 10 to $15\mu\text{m}^2$ large and the density of grooves in a cluster is 1 per μm^2 . A fracture cone measures approximately $50\mu\text{m}$ along one side. The damage depth for the grooves is approximately 0.2 to $0.4\mu\text{m}$ and the fracture cone depth varies from approximately 10 to $20\mu\text{m}$.

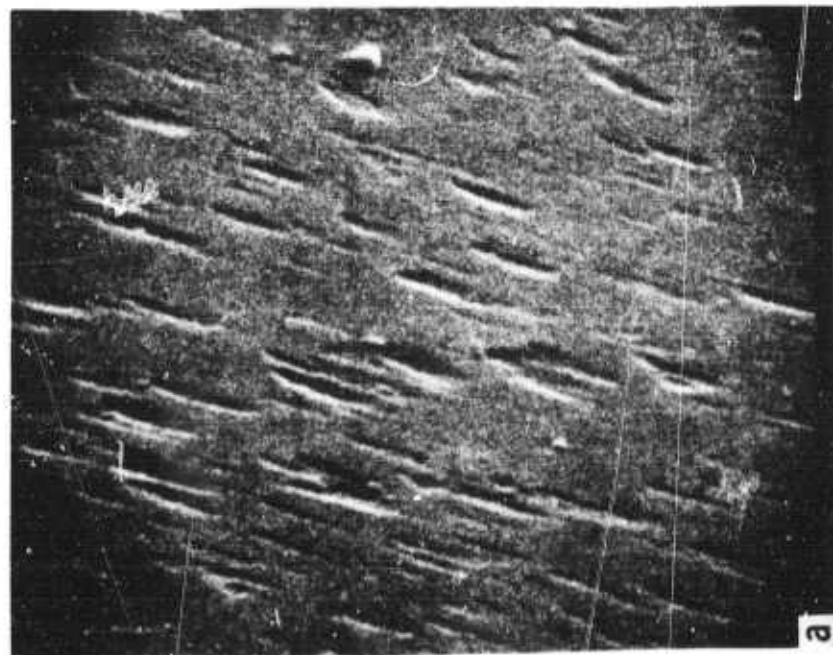
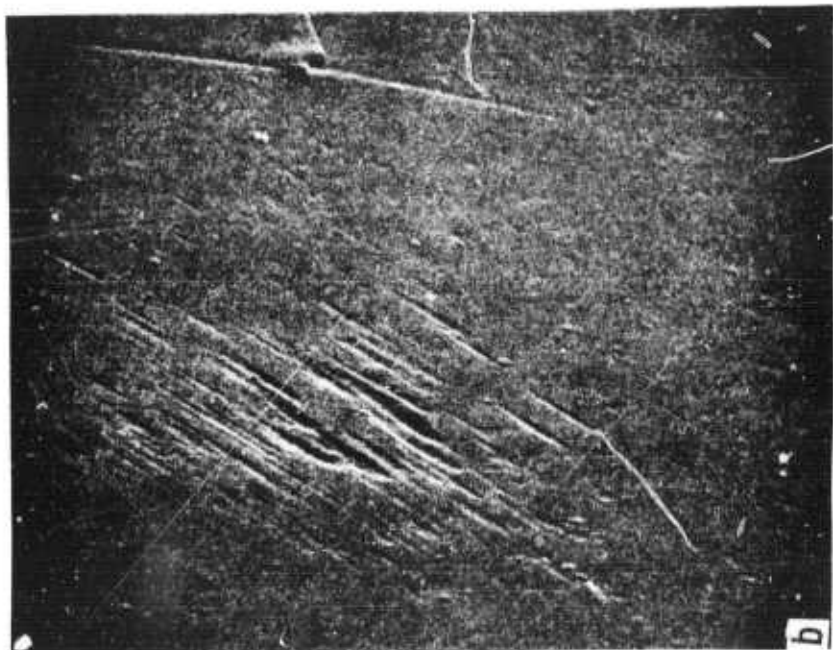
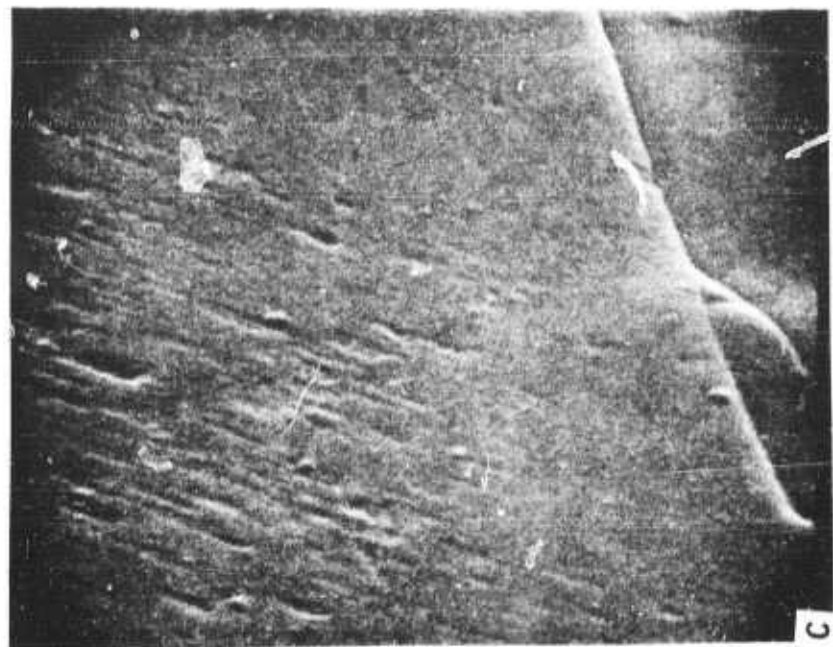
Fig. 2. Scanning electron microscope picture of cluster damage due to grooves as seen in Fig. 1a.

- a. at position A.
- b. at position B.
- c. at position C.

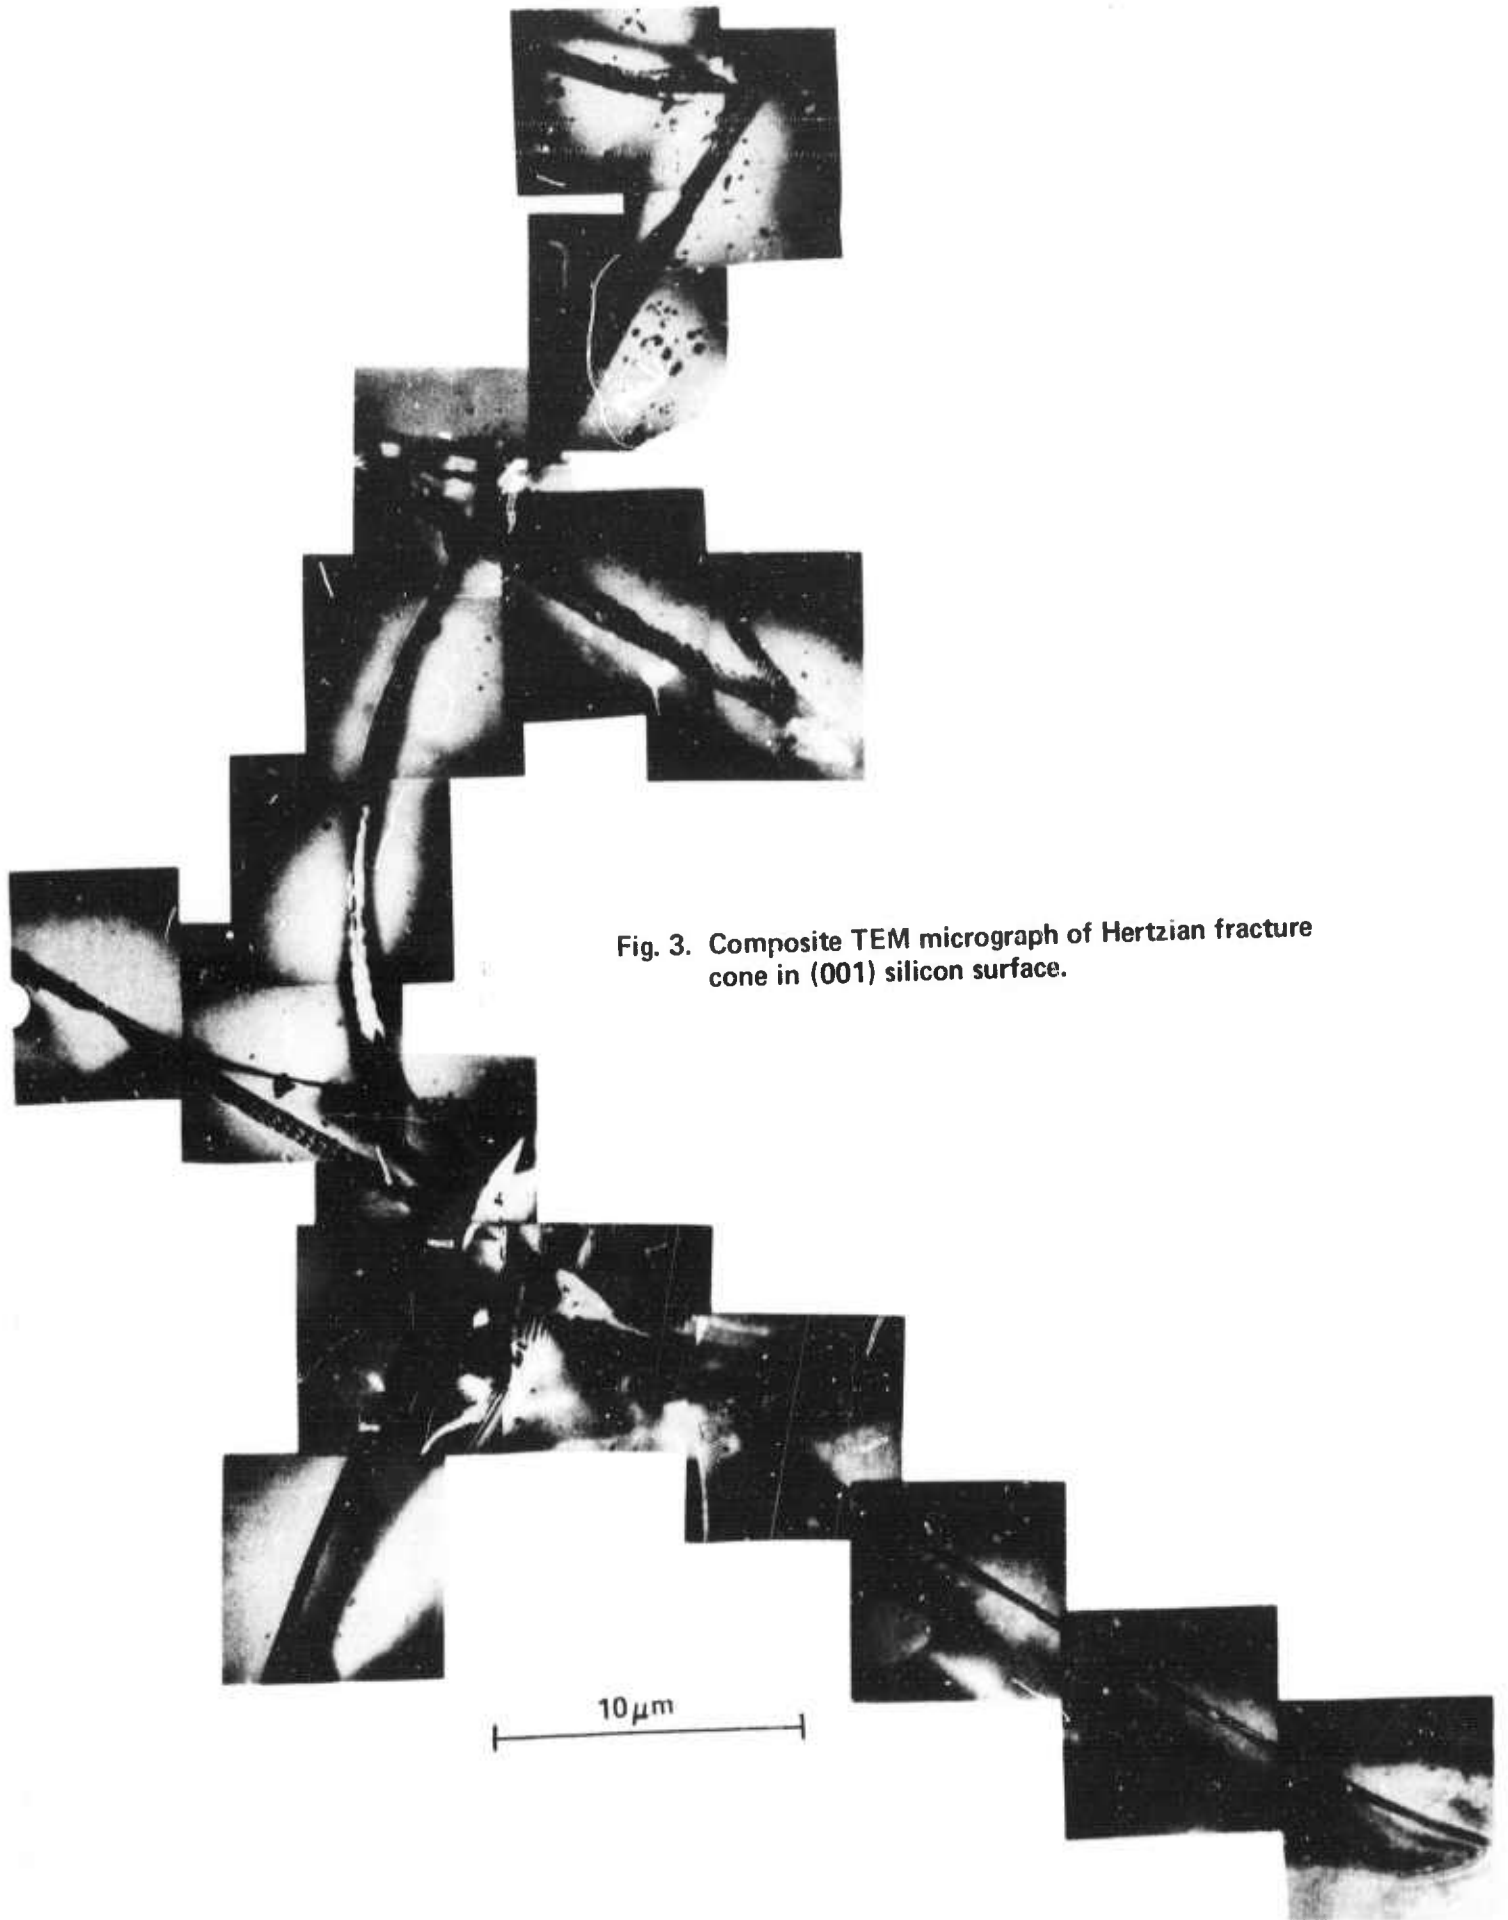
Fig. 3. Composite TEM micrograph of Hertzian fracture cone in (001) silicon surface.

Specimen preparation for electron microscopy of samples containing fracture cones is possible using standard jet etching techniques. Crack tips can be investigated when part of the sound stressed surface layer is removed by silicon dioxide polishing. A composite micrograph of a fracture cone split is shown in Fig. 3. This picture is unique because practically the entire split is available for inspection in the microscope. Only a small part around the 90° - bend is etched out during specimen preparation. The split in the silicon lattice is revealed through electron interference (Moire) fringes. Such fringes are characteristic for the fracture cones and indicate imperfect closure (out of registry) of the lattice.

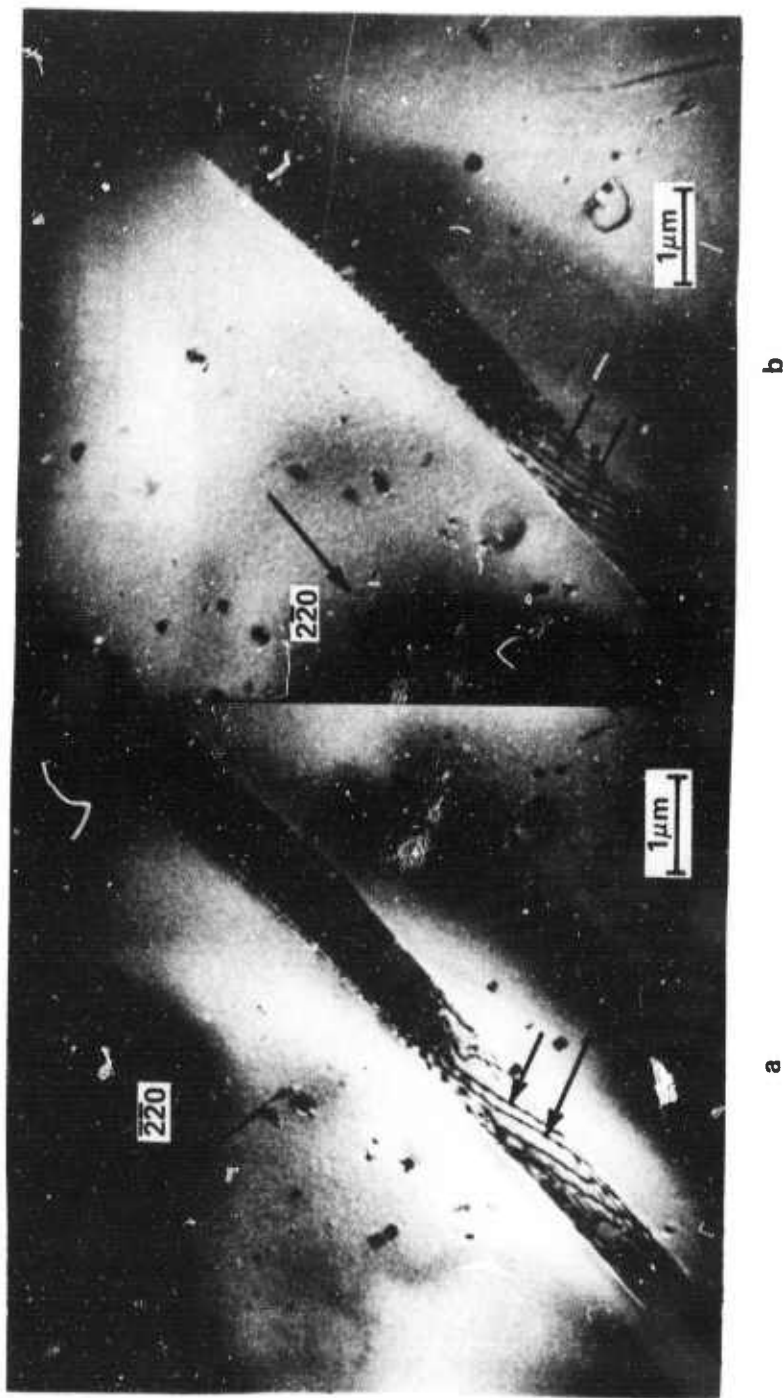
Fig. 4. Microcrack on a (111) plane showing cleavage dislocations and Moiré pattern. (a) $g = 220$ and (b) $g = 220$. Note: Cleavage dislocations stay in position.

In general all three effects are present simultaneously. Thus the lattice distortions overlap and produce a rather complicated Moire pattern. Simple patterns are seen for cracks lying in the cleavage planes. Such Moires consist of pure translational fringes and the crack image looks very much like a stacking fault. This similarity is very striking if "closure" of the crack has taken place. This is always the case for areas close to the crack tip. Examples are given in the micrographs of Figs. 4a and 4b. These micrographs are obtained from partially repolished samples.

Cleavage dislocations have also been discussed in the context of crack formation⁵. Such cleavage dislocations stay in position within the crack whenever the operating g-vector of the recording reflection is changed (Figs. 4a,b). Cleavage dislocations appear whenever the crack direction starts to deviate from the $\langle 110 \rangle$ direction. Examples of cleavage dislocation are also shown in Figs. 7a,b.

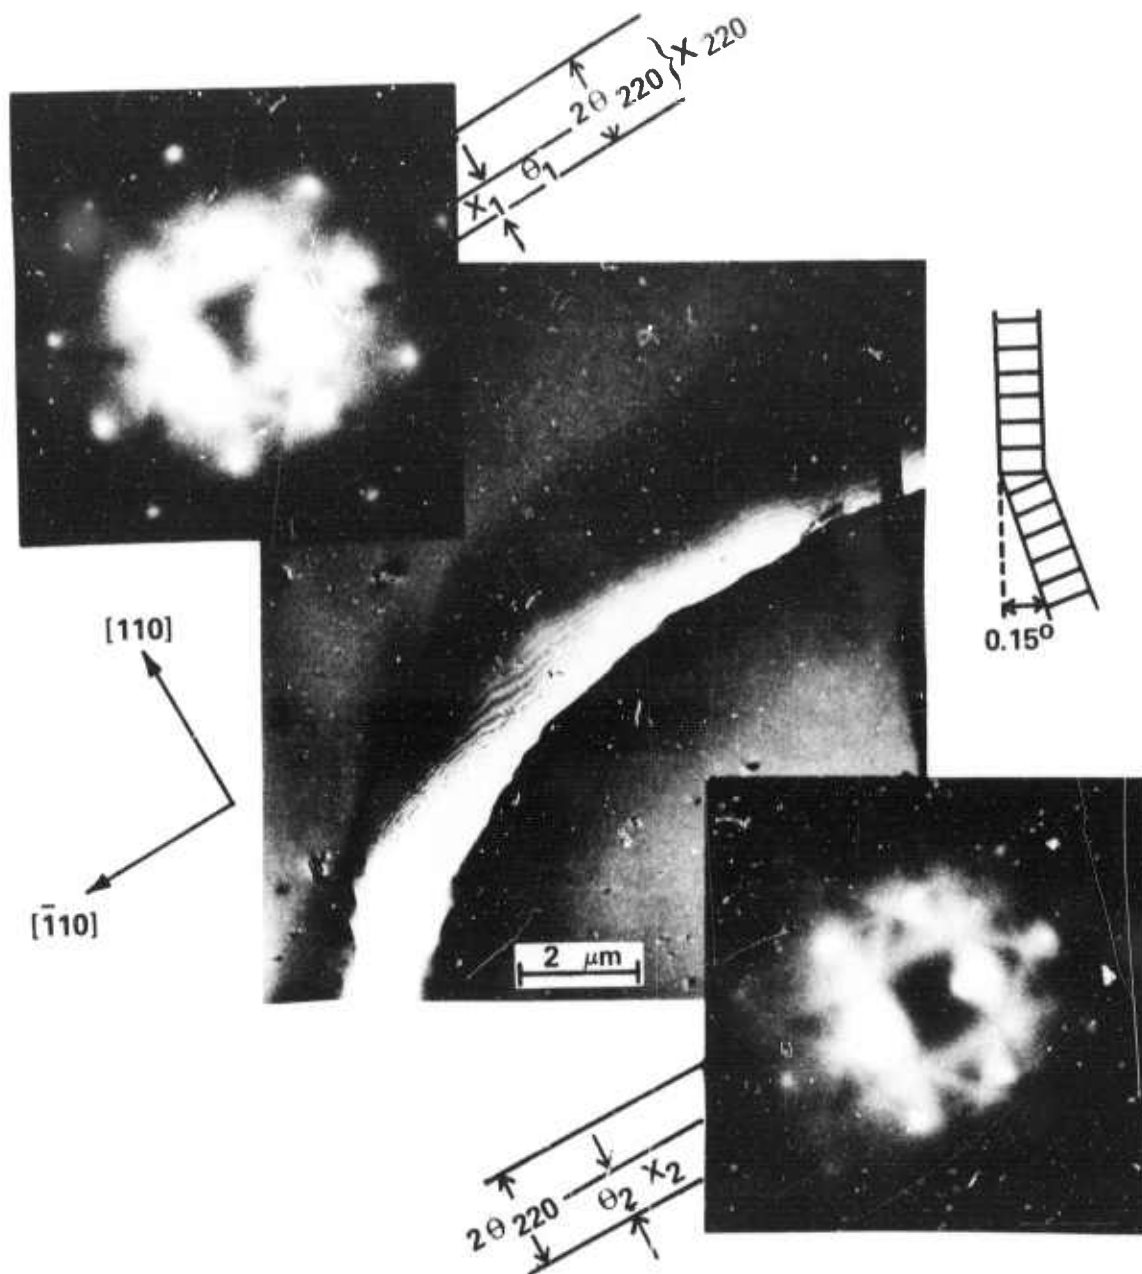
Fig. 5. Determination of crystal bending $\Delta\theta$ from the shift of the Kikuchi lines on one side of the crack with respect to the other. In the microcrack shown, $\Delta\theta = \theta_2 - \theta_1 \approx (X_2 - X_1)(2\theta_{220})/X_{220} \approx 0.15^\circ$ where $2\theta_{220} \approx 0.75^\circ$.

The degree of bending introduced into the wafer surface as described in (B) can be estimated quite accurately by observing the shift of Kikuchi lines in the diffraction patterns generated by the two crystal parts. This is shown in the micrographs of Figs. 5 and 6. The amount of bending introduced by the fracture

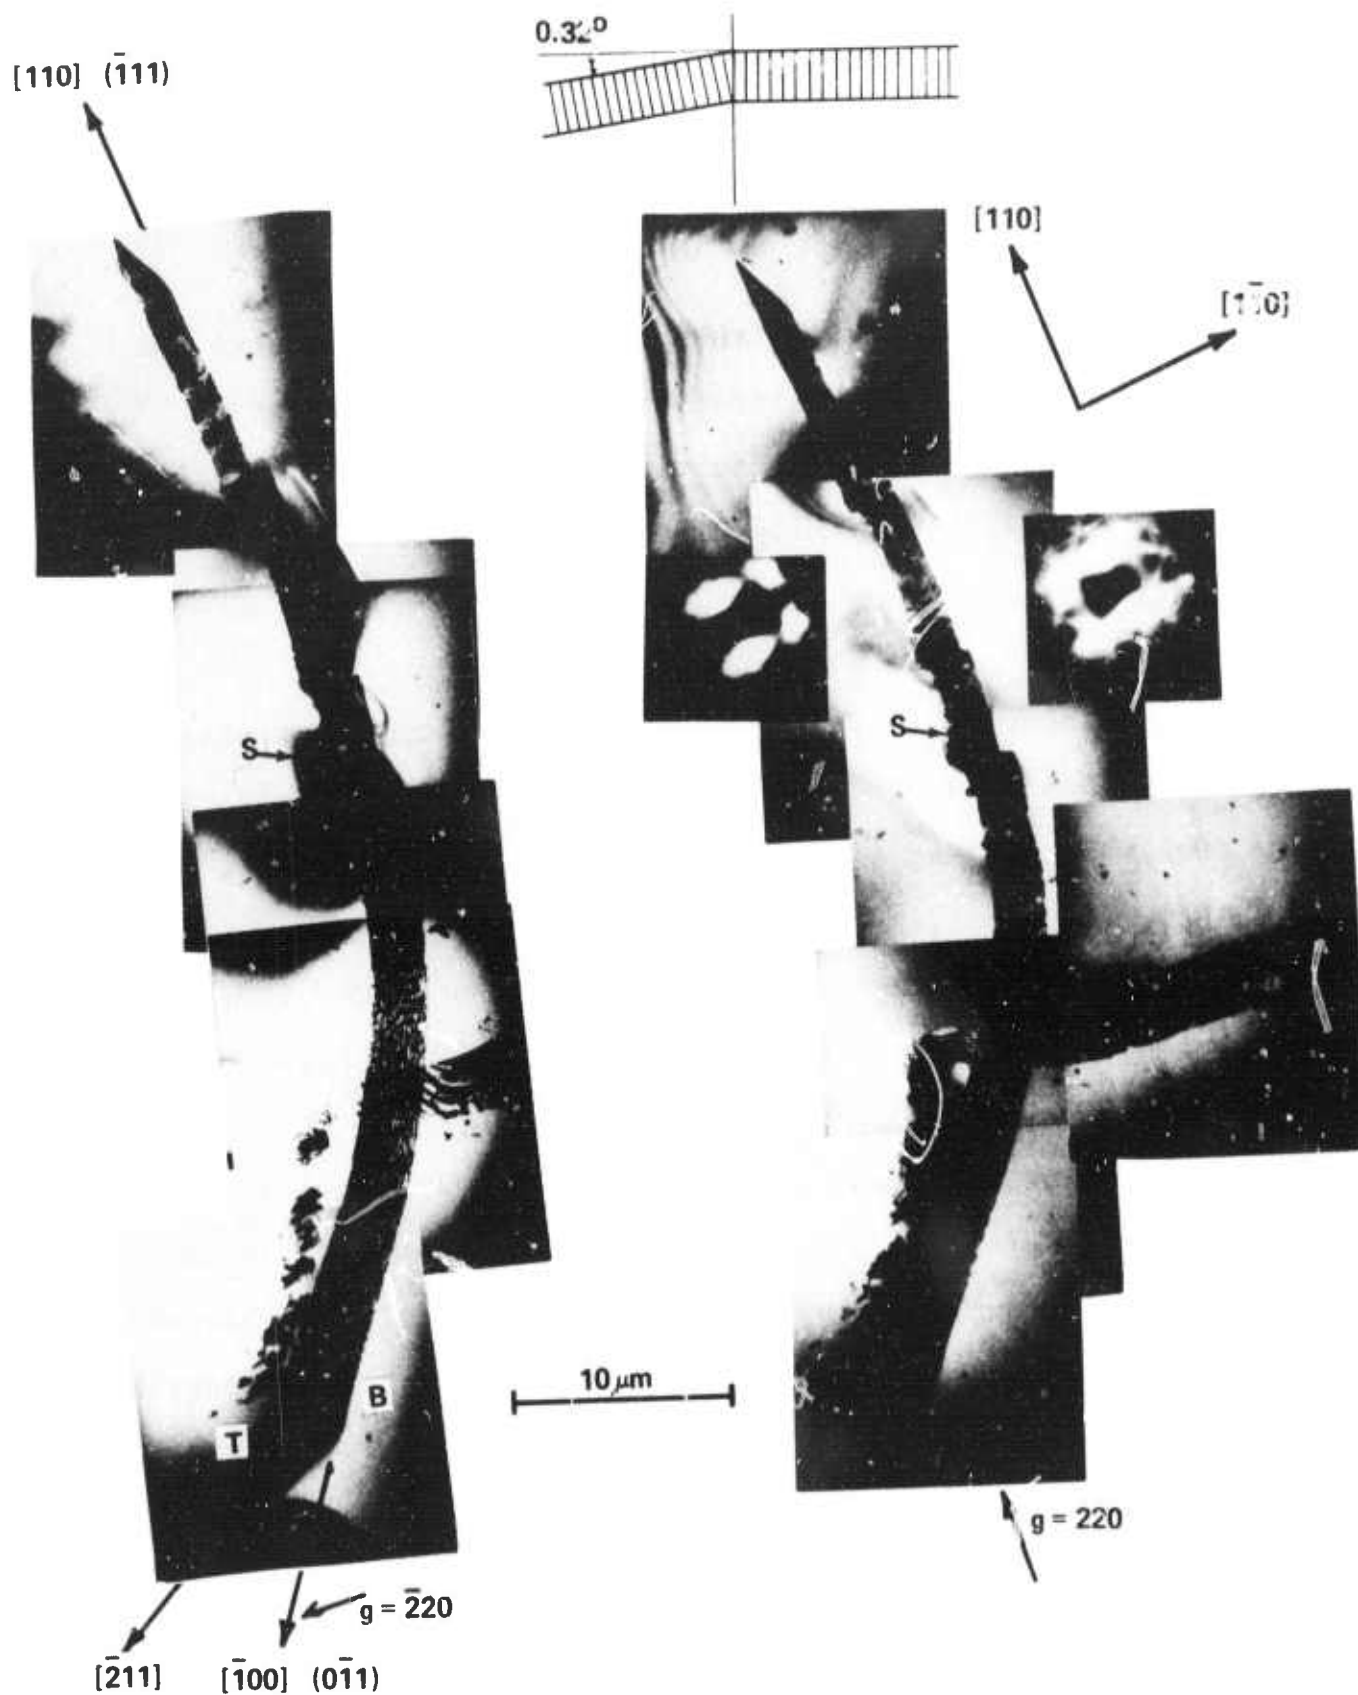
Fig. 6. Microcrack in $\langle 110 \rangle$ and $\langle 100 \rangle$ direction. The crack is located on a $(\bar{1}11)$ plane at the upper section of the photomicrograph and on a $(0\bar{1}1)$ plane at the lower section of the micrograph. Note: T = Top of crack; B = Bottom of crack; S = Stress center.

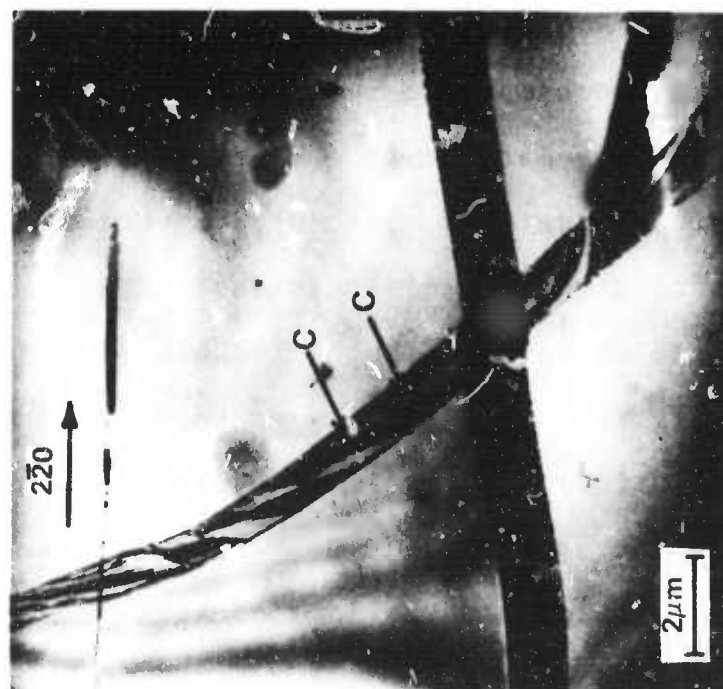
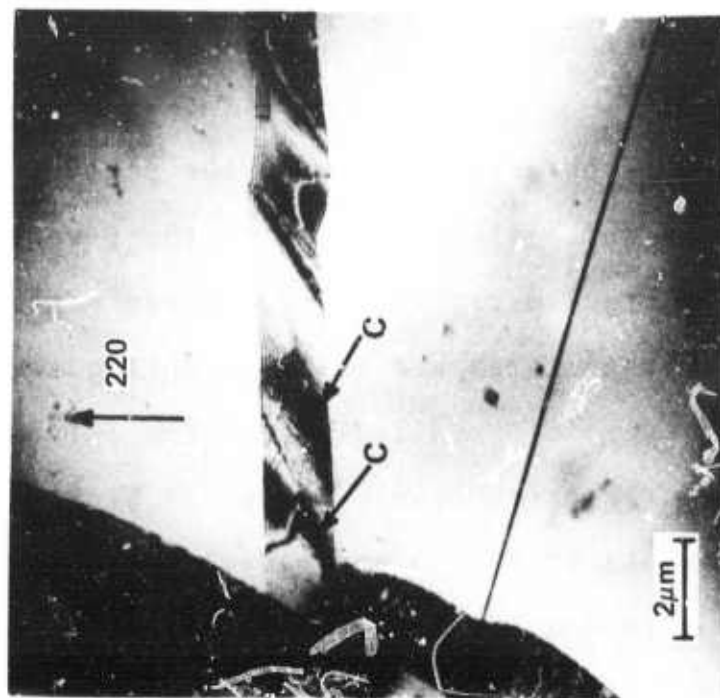
Fig. 7. Microcrack 10 μm below the surface showing cleavage dislocations and Moire pattern similar to stacking fault contrast. (a) $g = 2\bar{2}0$, (b) $g = 220$ reflection. Note cleavage dislocations at C.

The boundary line terminating the crack inside the crystal has been compared to an edge dislocation⁵. In (001) silicon we find that such boundary lines terminating cracks lie on (111) planes and have (011) or (112) directions. This is shown in the micrographs of Fig. 7.

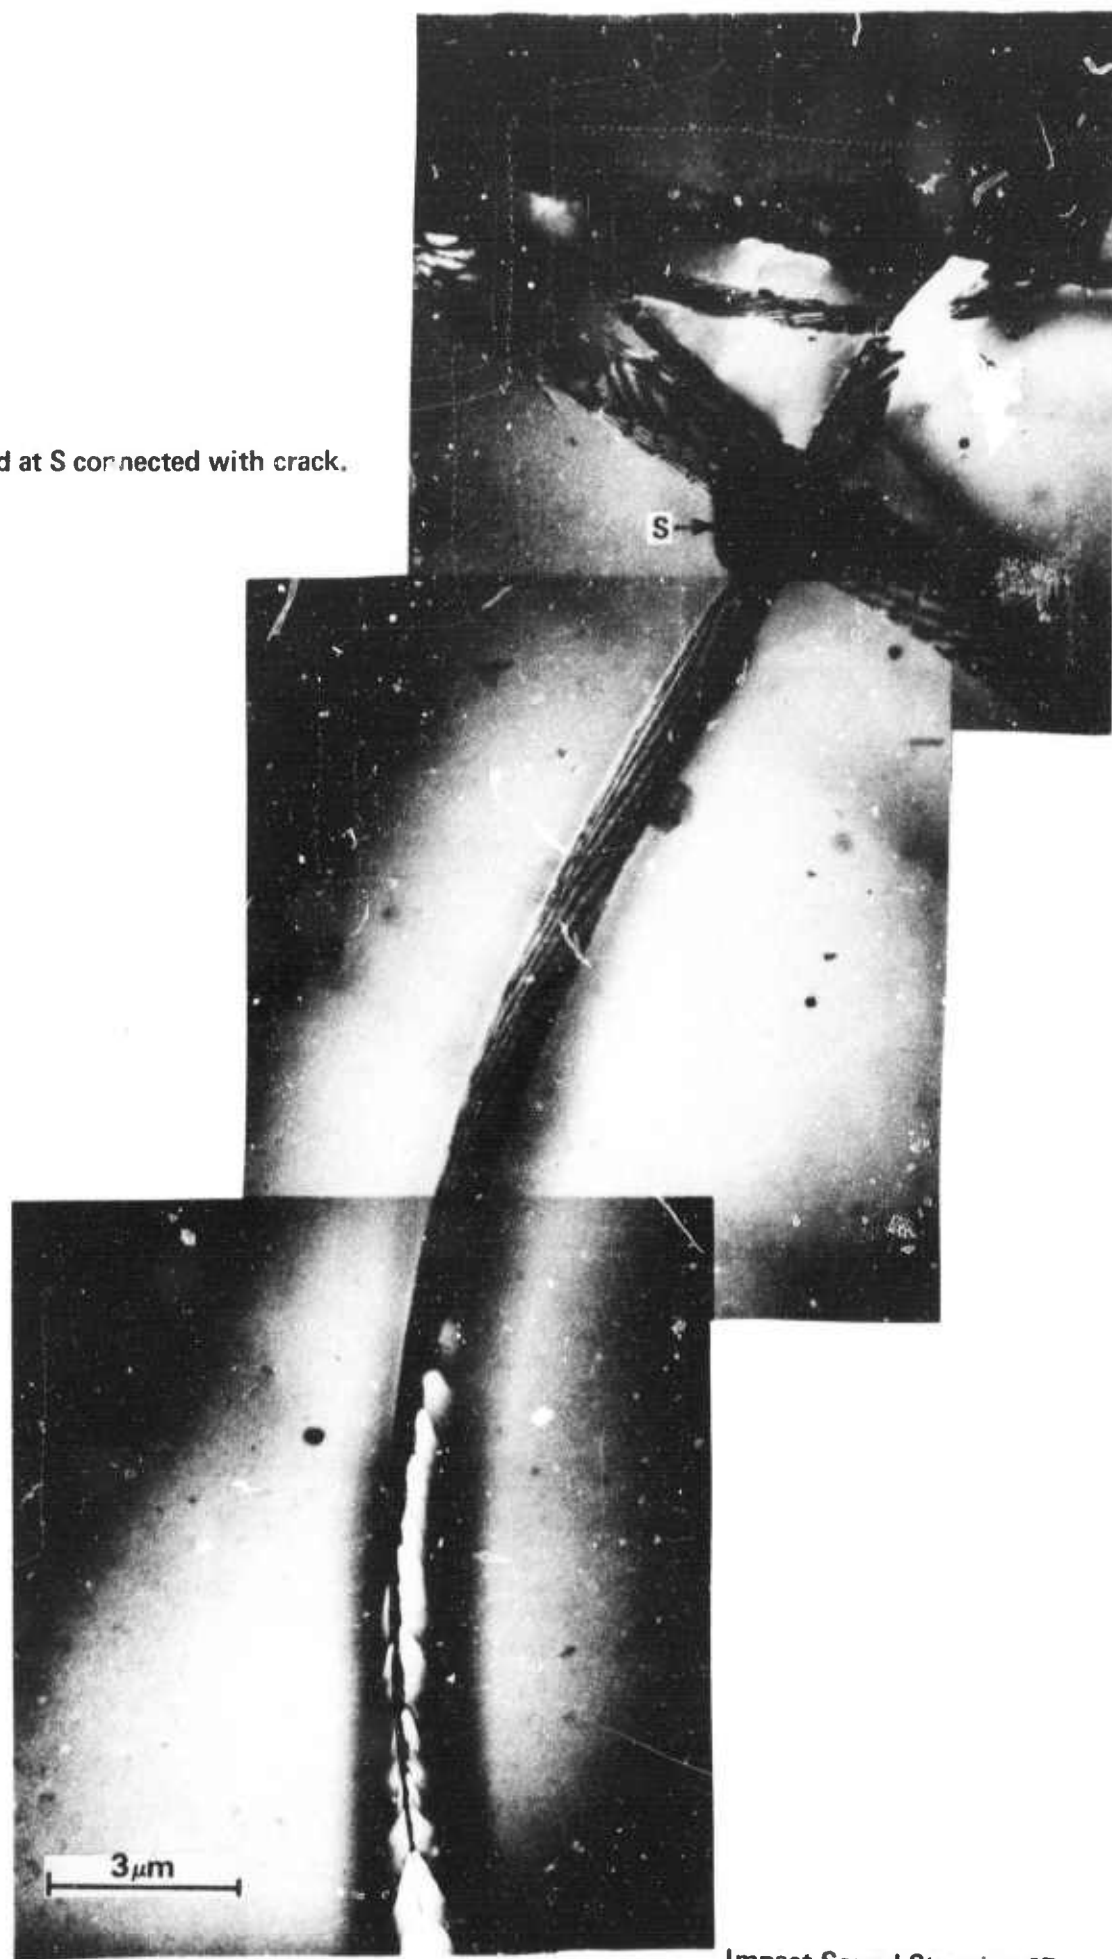
Fig. 8. Strain field at S connected with crack.

A large strain field is observed in the center part of the crack shown in Fig. 8 which is recorded with the g-vector perpendicular to the crack direction. Such large strains inside the cracked crystal area are relieved during sample annealing. However, sample annealing causes the formation of dislocations outside the crack area. A typical example is shown in the micrographs of Fig. 9 and reveals dislocation formation in ISS'ed samples after annealing in nitrogen. Similar results are obtained for annealing in oxygen.

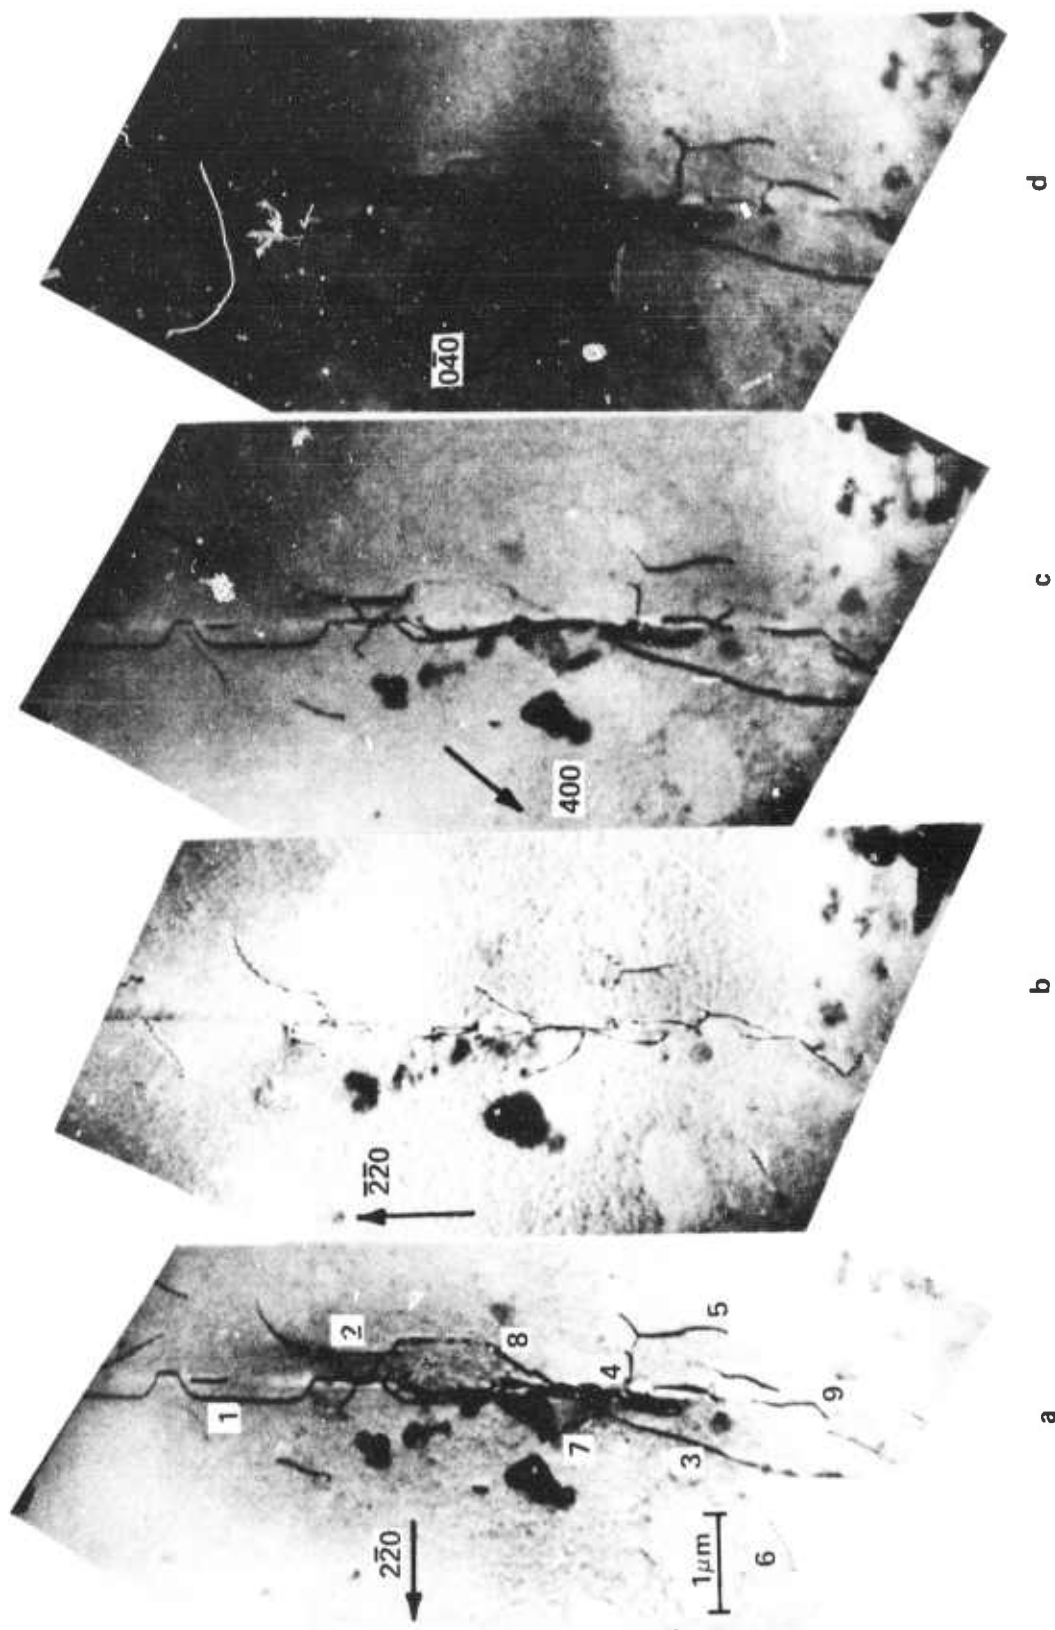
Fig. 9. Area of a microcrack after 1 hr anneal at 1100°C . Micrographs recorded with different operating g -vectors for Burgers vector analysis. (a) $2\bar{2}0$, (b) $2\bar{2}0$, (c) 400 , (d) 311 reflection.

The simple equation $\theta = N \cdot b / D$ can be used to estimate the number of dislocations necessary to relieve the strain connected with a crack in the lattice (θ = lattice tilt due to crack, N = number of dislocations, b = Burgers vector of dislocation, D = spacing between dislocations). The lattice tilt θ can be measured using the Kikuchi technique as described in connection with Fig. 5. This tilt is approximately 0.15 degrees. Thus it is calculated that only 6 dislocations are necessary to relieve the strain field connected with a fracture cone line in silicon. This value is in good agreement with the experimental findings (Fig. 9).

Numerous Burgers vector investigations of dislocations around fracture cones after different annealing cycles were performed. All the Burgers vectors observed in connection with strain relief through dislocation generation in ISS'ed wafers are summarized in Table I. Representative electron micrographs of the detailed analyses performed are given in the various micrographs of Fig 9. A Kikuchi line map indicating the different tilt position of the specimen for the recording of the micrographs of Fig. 9 is given in Fig. 10.

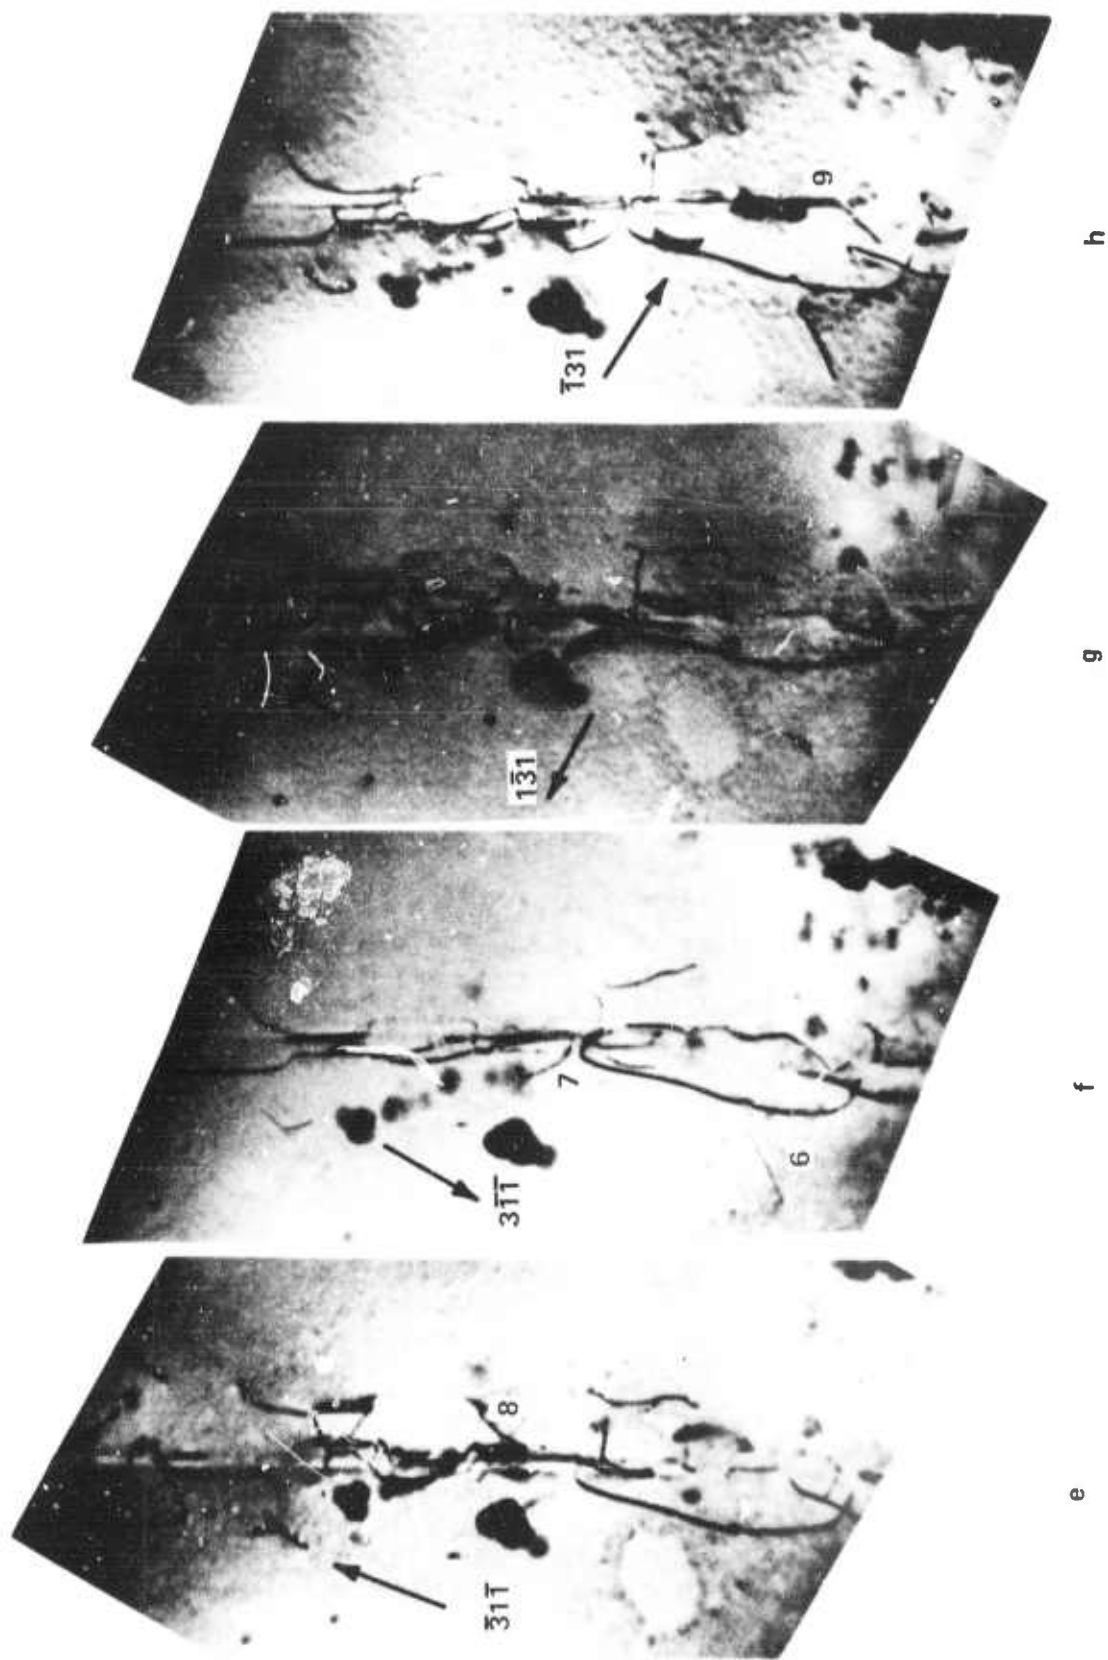
Fig. 9. Area of a microcrack after 1 hr anneal at 1100°C. Micrographs recorded with different operating g-vectors for Burgers vector analysis. (e) $31\bar{1}$, (f) 040 , (g) $1\bar{3}1$, (h) $1\bar{3}1$ reflection.

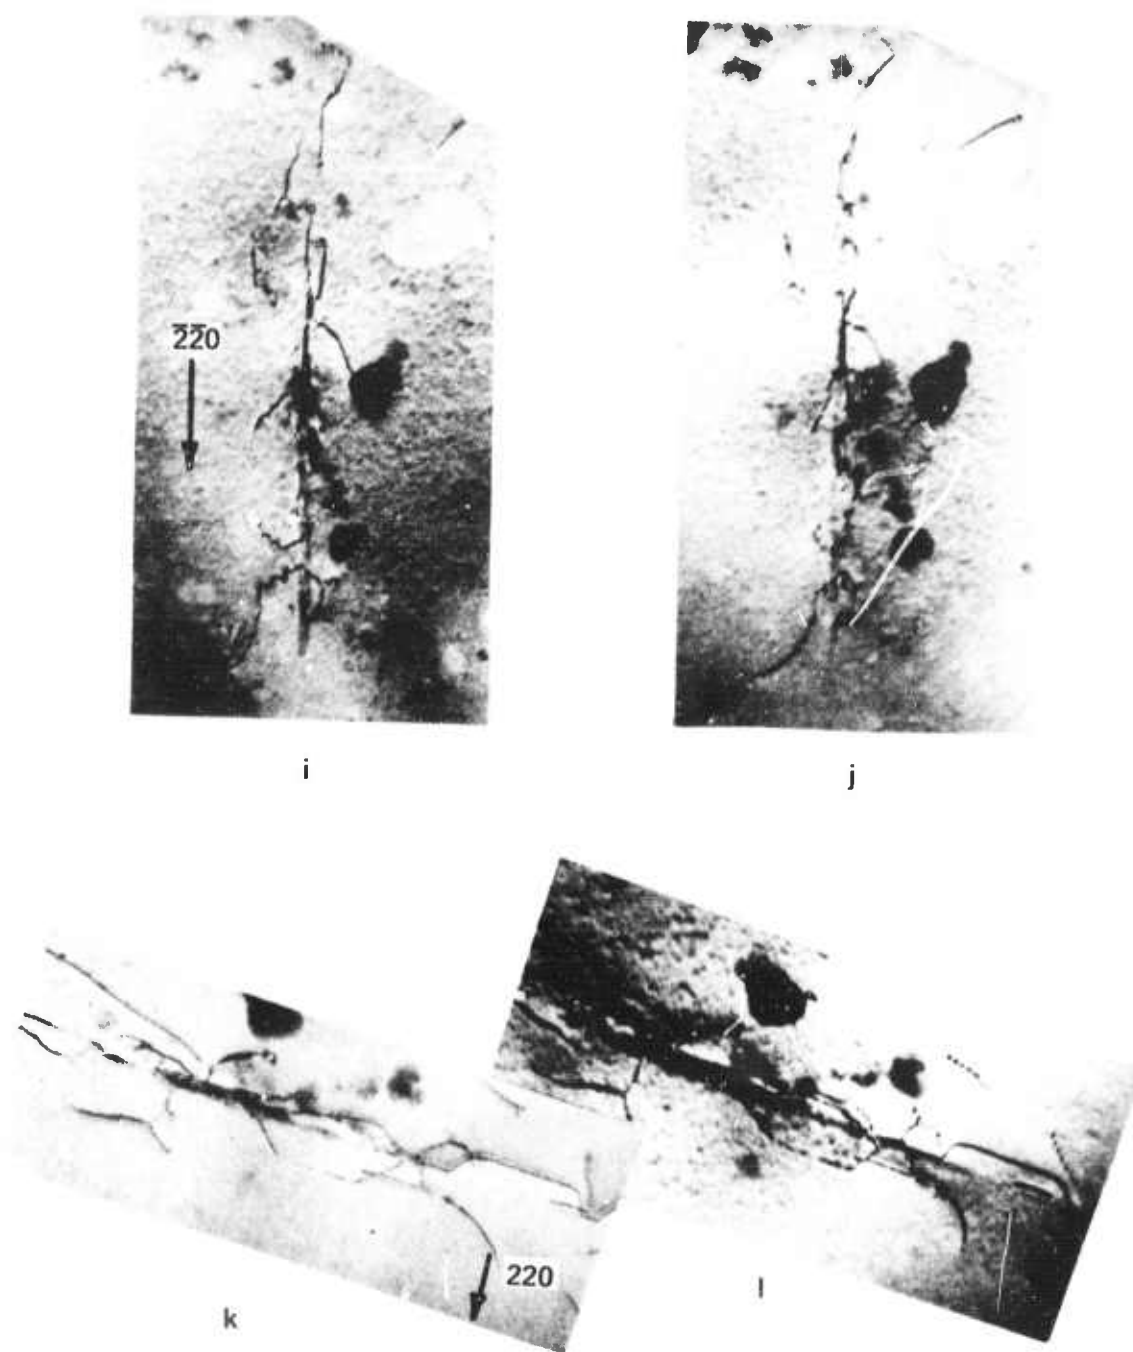
Fig. 9. Area of a microcrack after 1 hr anneal at 1100°C. Micrographs recorded with different operating g-vectors for Burgers vector analysis.

(i) and (j) stereo set taken with $\bar{2}\bar{2}0$ reflection;
 (k) and (l) stereo set taken with $2\bar{2}0$ reflection.

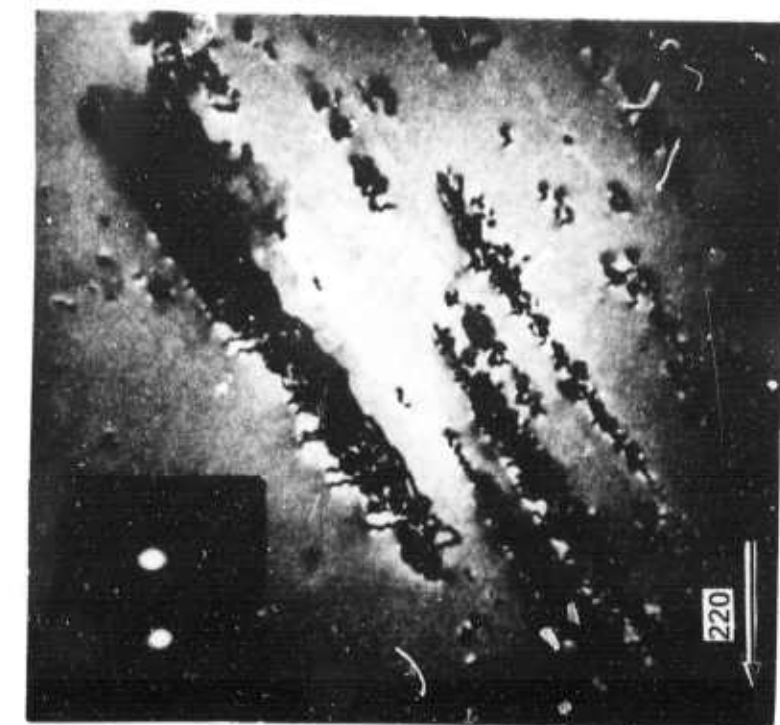
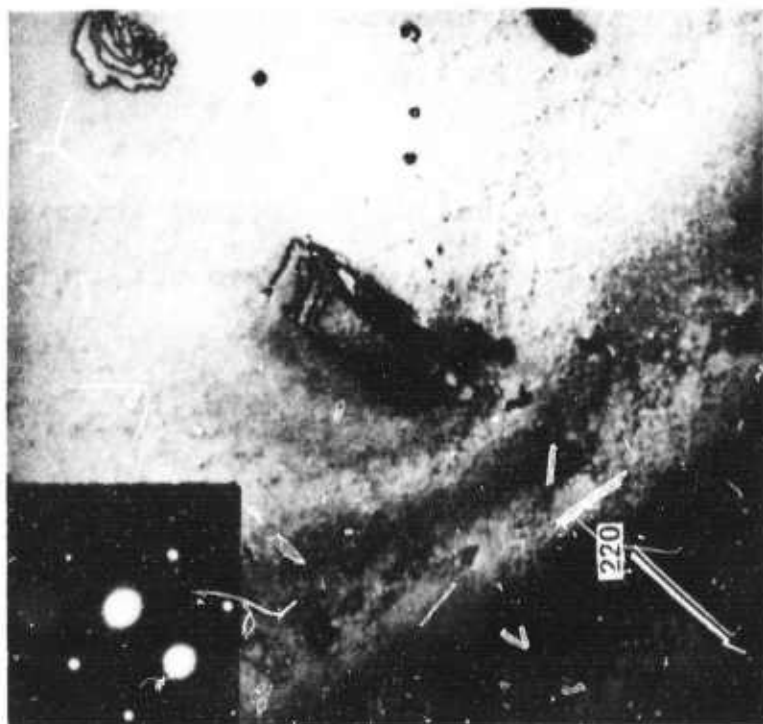
Fig. 11. TEM micrograph of grooves showing dislocation bands.

This type of ISS damage on silicon surface is responsible for dislocation bands. A typical example is given in Fig. 11. Such dislocation bands are composed of dislocation loops and appear in rows oriented along $\langle 100 \rangle$, $\langle 110 \rangle$ or $\langle 120 \rangle$ directions (Fig. 1a). However, the intersections of all loops with the (001) surface is always a $\langle 110 \rangle$ direction indicating that the loops are located on (111) glide planes. Stereo-micrographs of such dislocation bands are given in Figs. 12 and show loops in (111) and ($\bar{1}\bar{1}\bar{1}$) planes.
